Location of Buried Concrete Trenches
Hitachi GST
San Jose, California

ATTACHMENT IV
SOIL INSPECTION/SAMPLING PLAN
FOR HYDRAULIC ELEVATORS

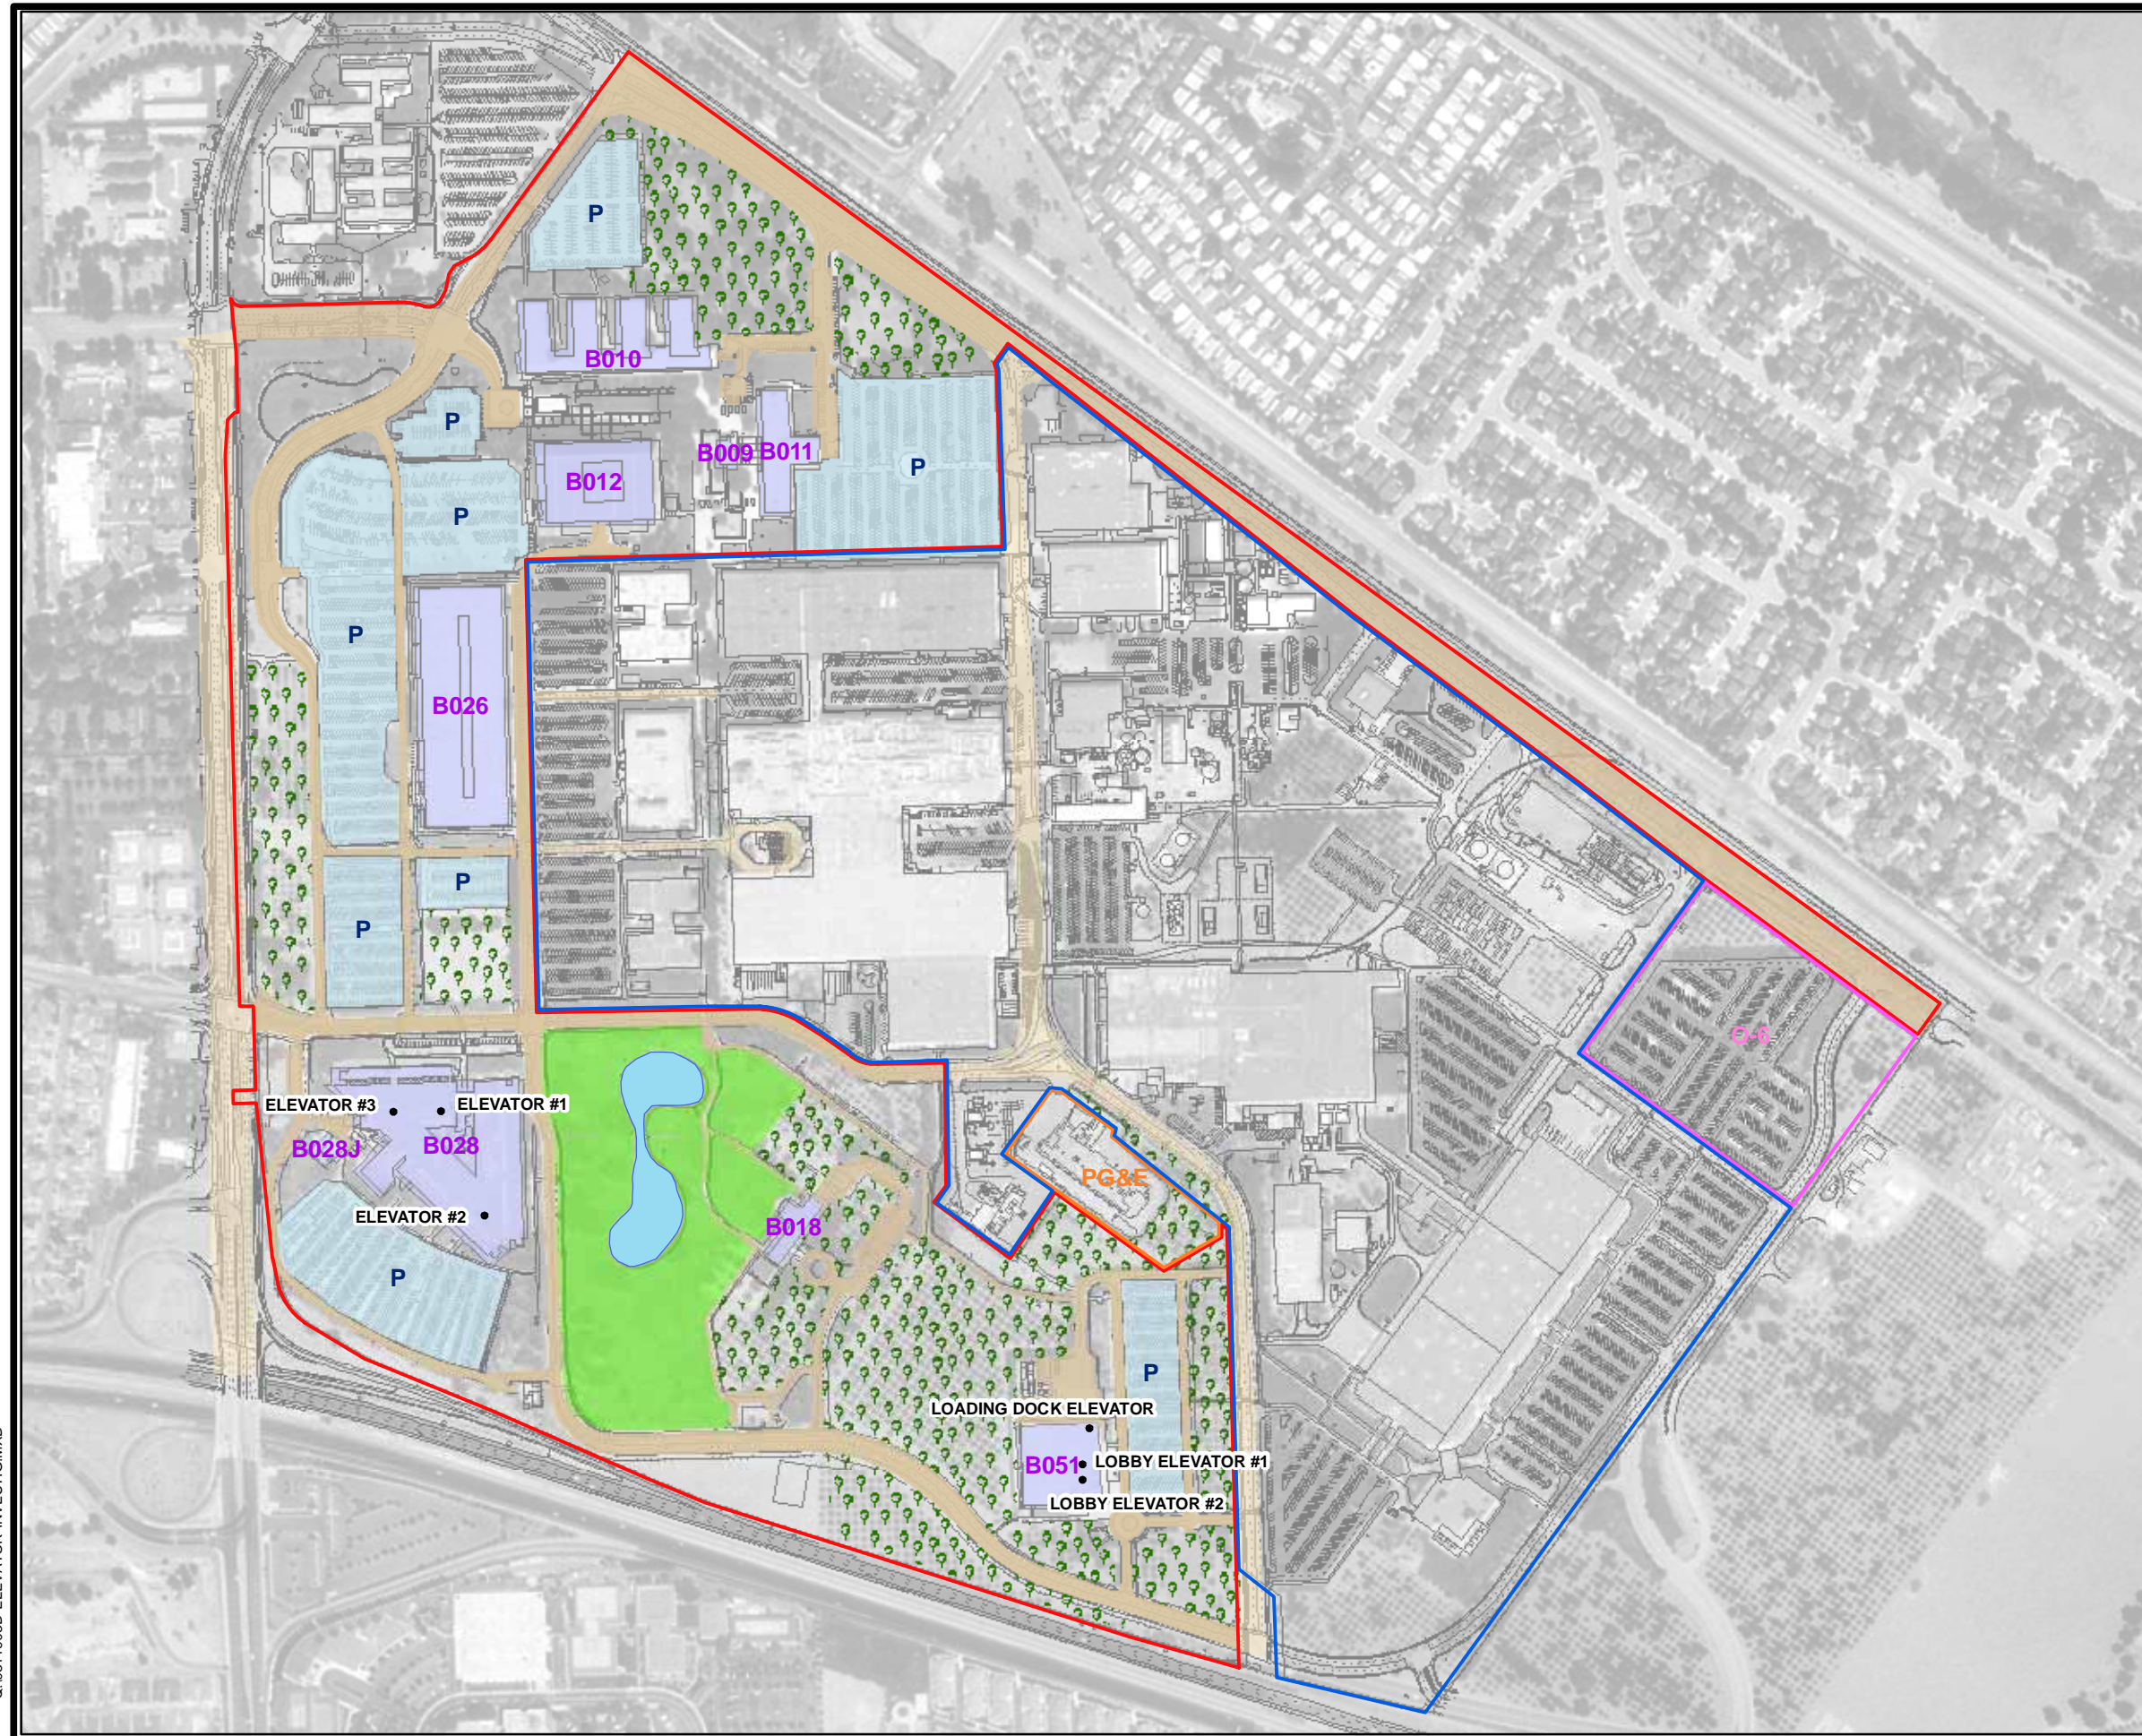
The location of these elevators are shown in Figures IV.1 through IV.3. The results of this Soil Inspection/Sampling Plan will be used to determine if any mitigation/remediation measures are needed at the Site due to hydraulic fluids in soils from hydraulic elevators.

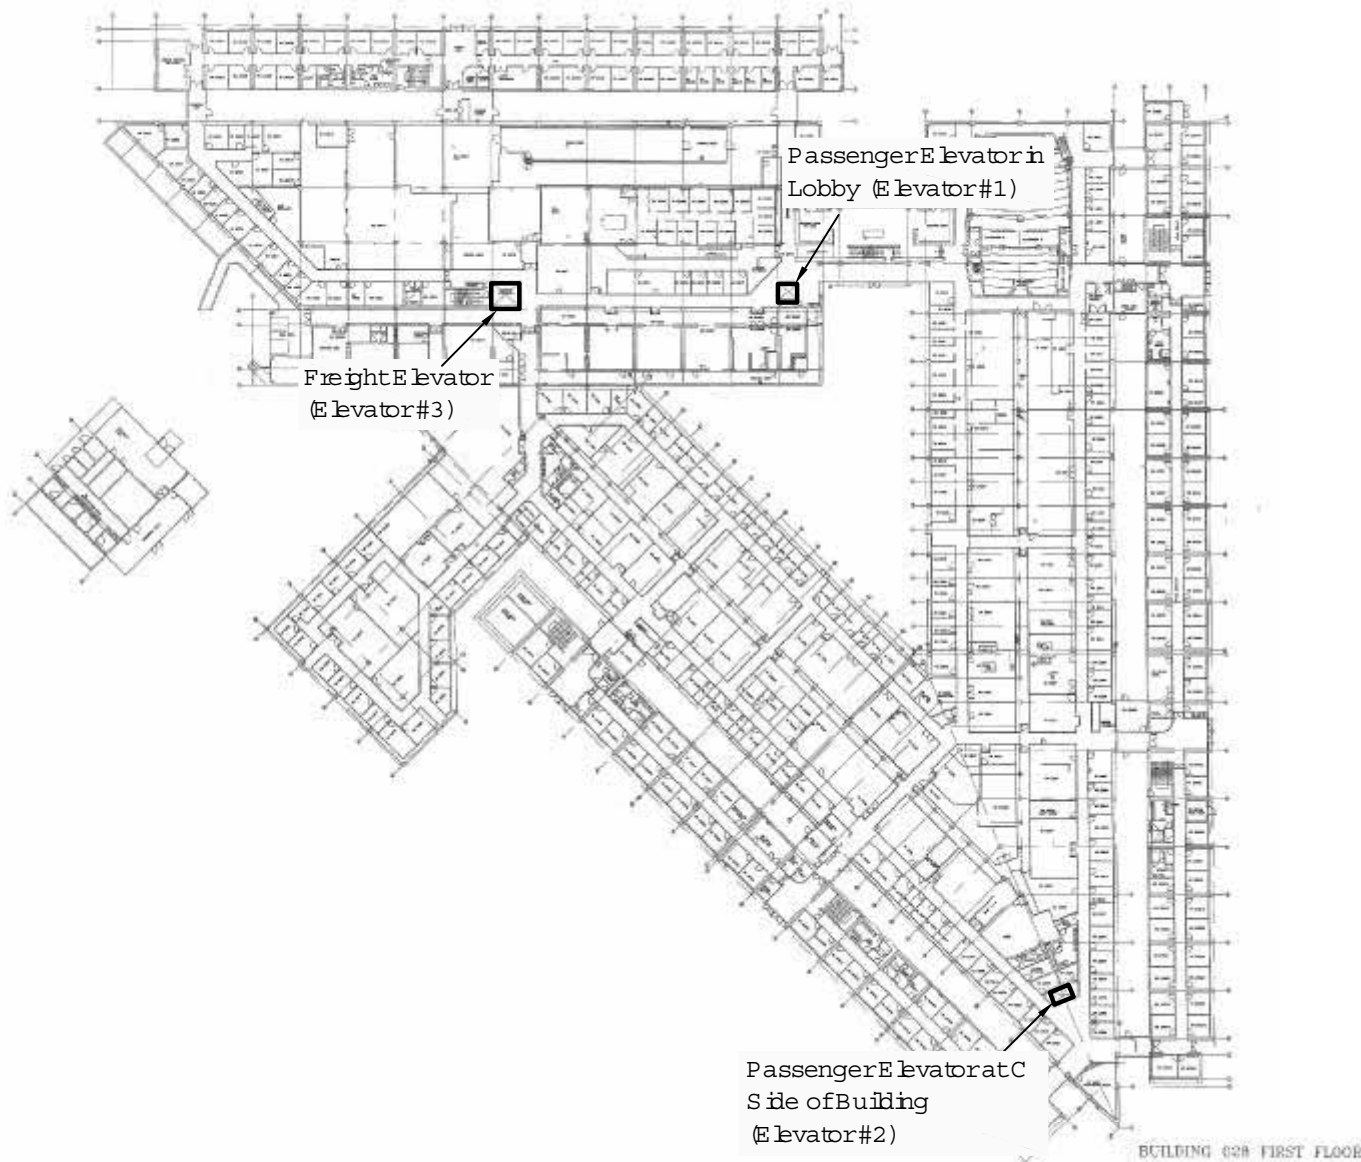
Location of Hydraulic Elevators to be Evaluated/Investigated in Building 028
 Hitachi ST
 San Jose, California

There are three hydraulic elevators in Building 028 referred to here as the freight elevator (Elevator No. 3), the passenger elevator in the lobby (Elevator No. 1), and the passenger elevator at C side of building (Elevator No. 2). The oil reservoir capacity of each hydraulic elevator varies, but ranges from 30 to 75 gallons. All of the oil reservoirs are equipped with secondary containment. Hitachi GST personnel reported that the elevator contractor inspects the elevator pits monthly. Several soil investigations associated with hydraulic elevators in Building 028 have been conducted in the past, as described below:

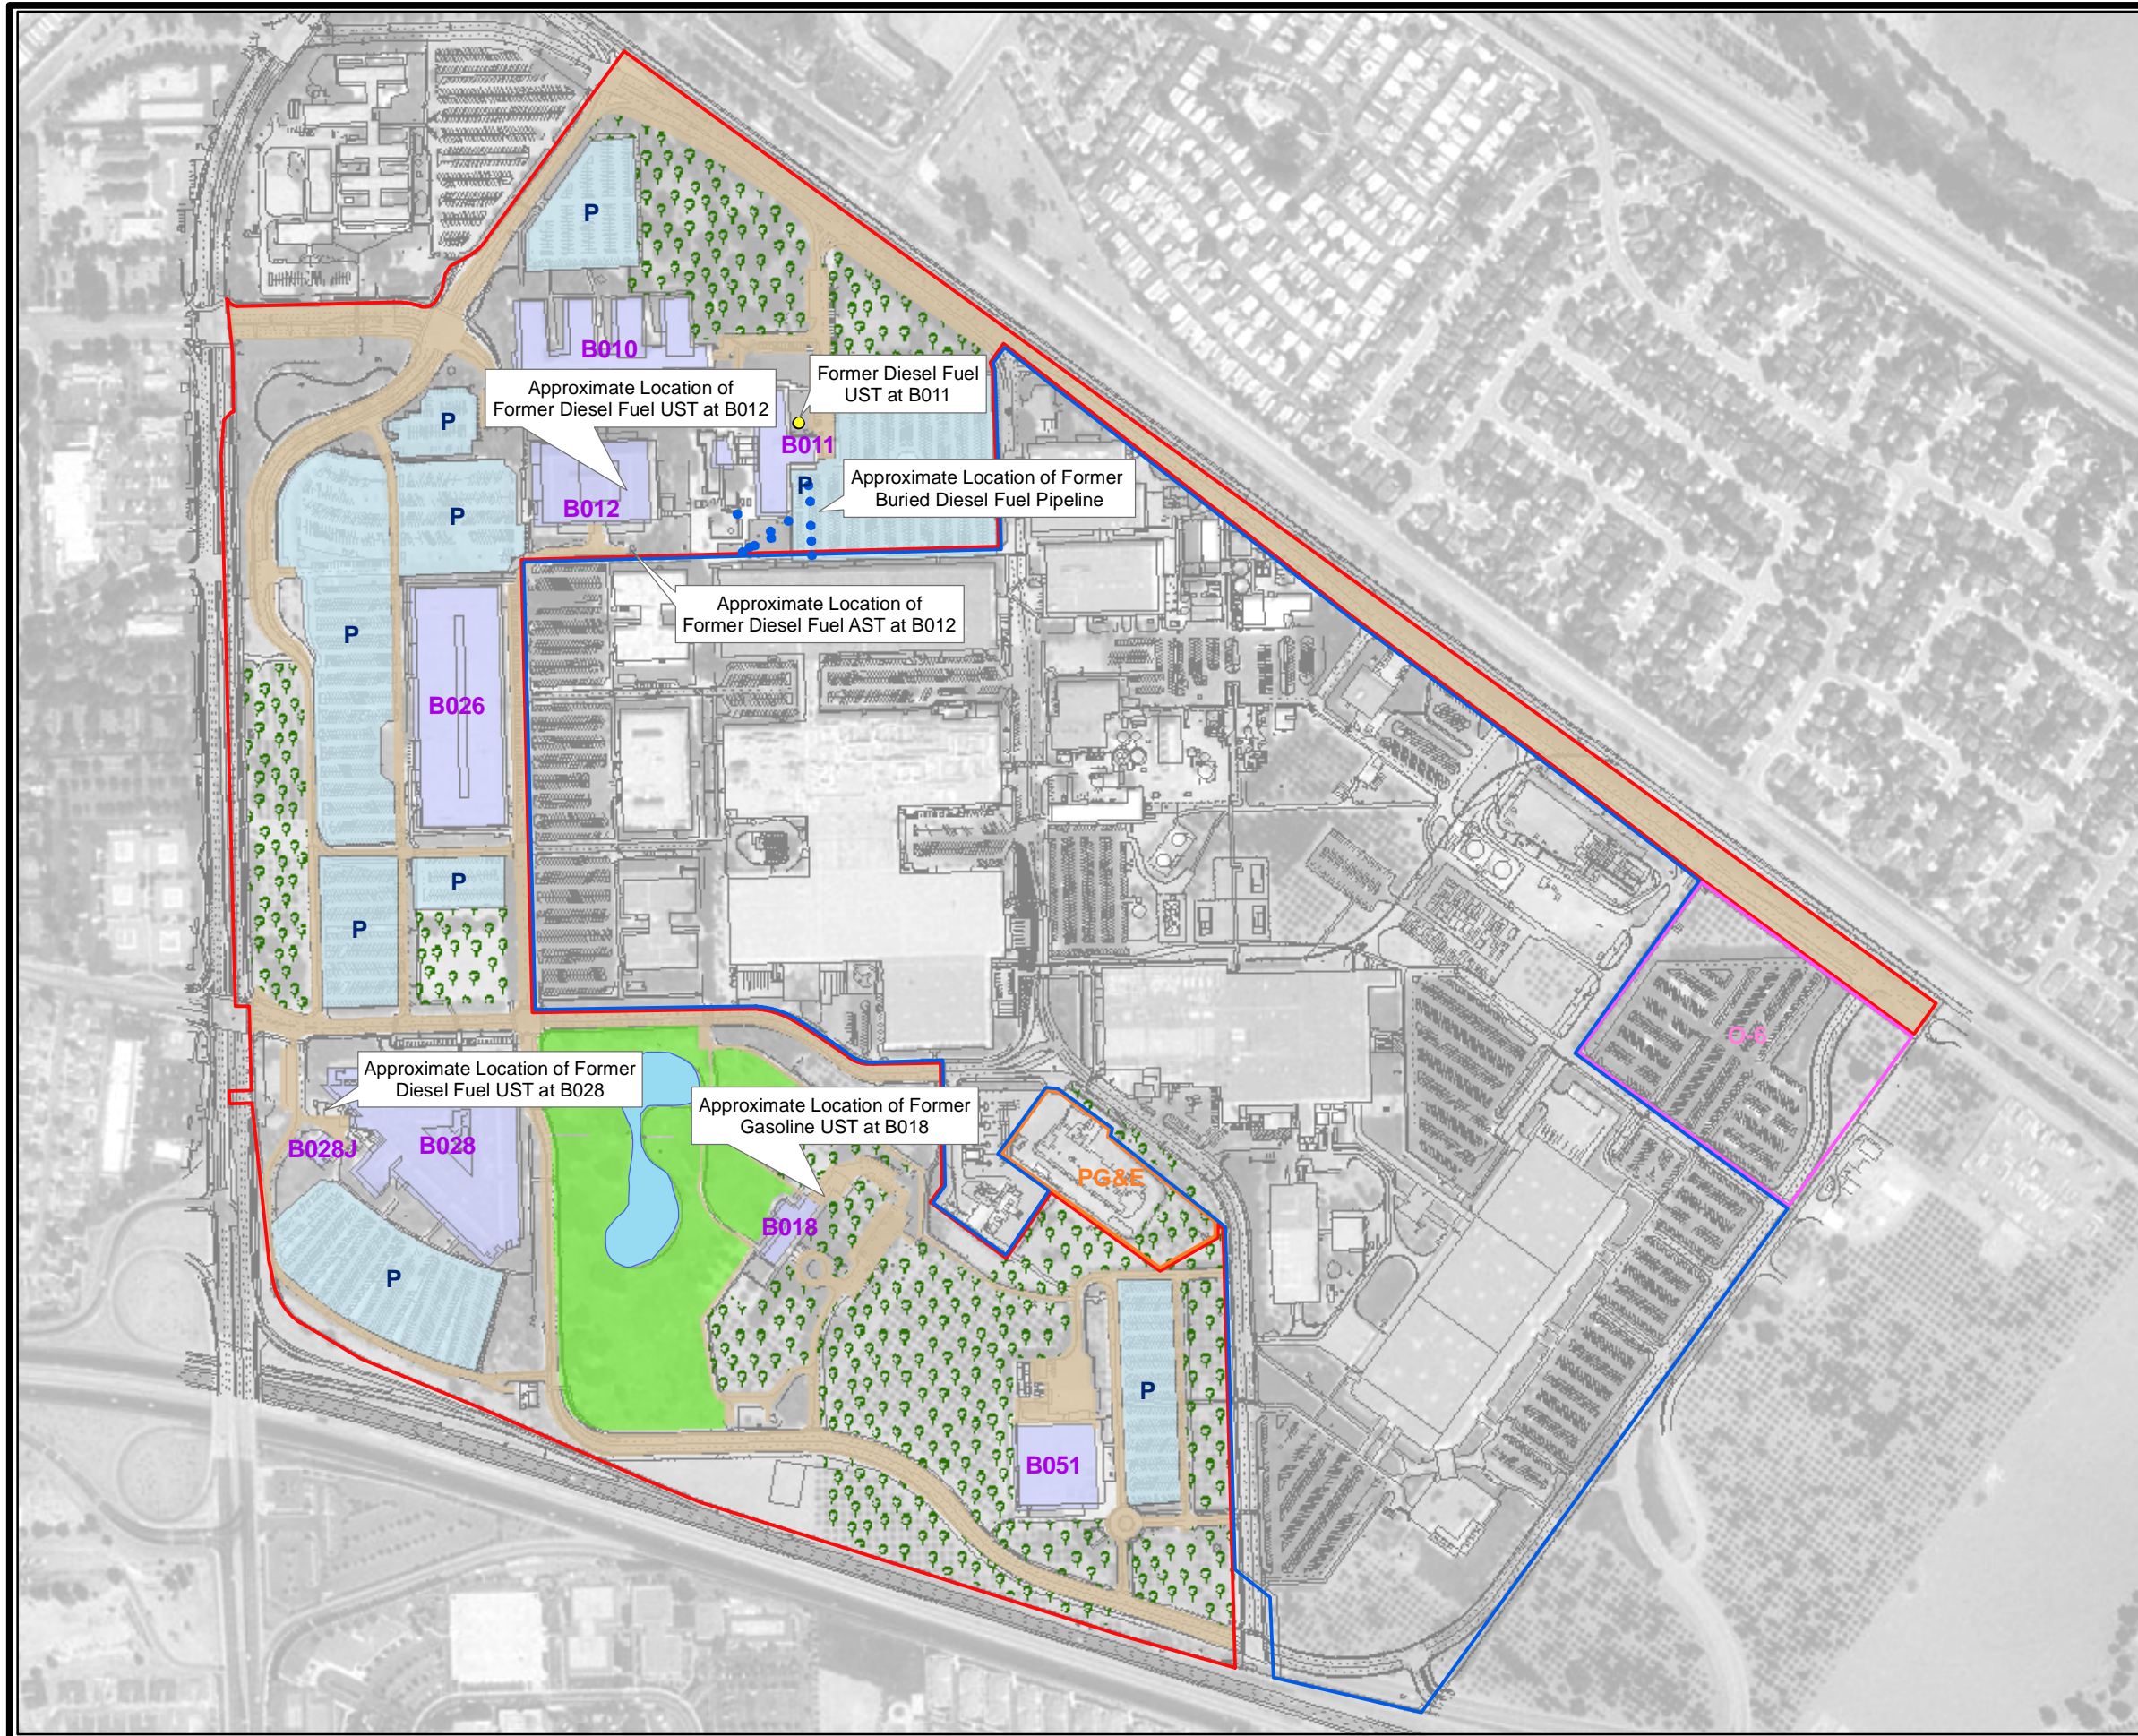
As described above, soil sampling is recommended at the former 1,000-gallon diesel fuel UST at Building 011. Two soil borings will be advanced beneath the location of the former tank (one at either end). The proposed sample locations are summarized in Table V.1 and are shown on Figure V.2. Soil borings will be advanced to a depth below the tank's excavation (approximately 15 feet bgs) using a GeoProbe direct-push rig (truck-mounted and limited-access) using single-walled tooling. Four soil samples will be collected from the soils beneath the former diesel fuel UST at depths of approximately 10 and 15 feet bgs. Samples will be collected in either stainless steel or acetate sleeves, capped with Teflon™-lined caps, placed in Ziploc™-type plastic bags, and stored on ice in a cooler. In addition, soils will be field screened for volatile organic compounds (VOCs) during drilling activities using an Organic Vapor Monitor (OVM) and additional samples may be added based on the results of this monitoring.
